Faulty geology halts project

Stratigraphic studies by the NPD in the wake of an oil leak on Tordis have shown that the Utsira formation is not present where an injection well was drilled for this North Sea field.

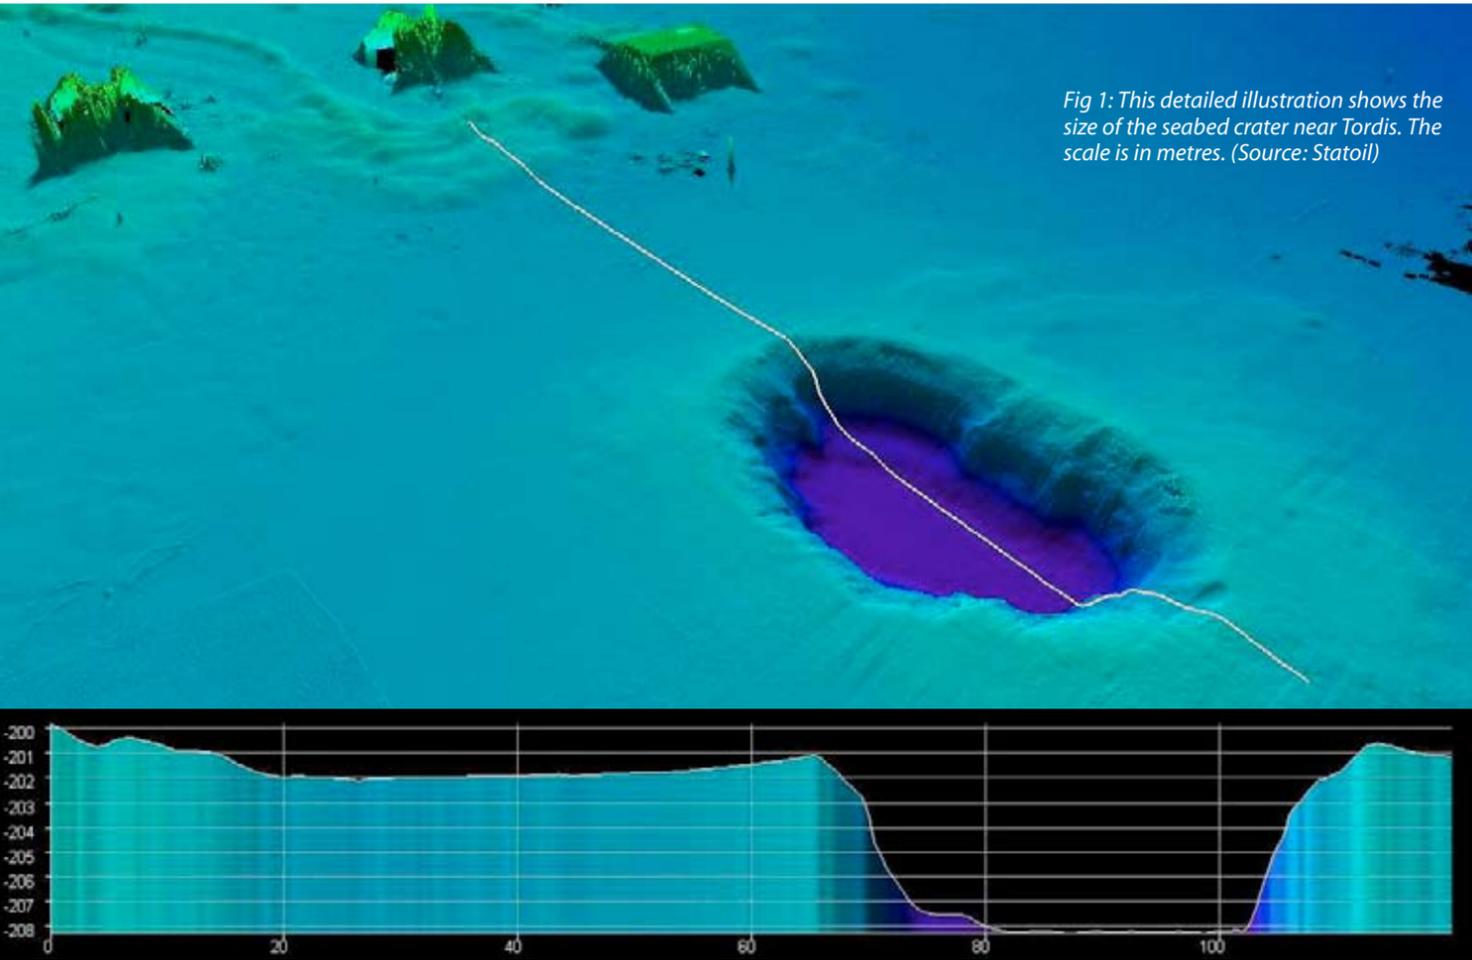
Fig 1: This detailed illustration shows the size of the seabed crater near Tordis. The scale is in metres. (Source: Statoil)

Measuring 30-40 metres across in the longitudinal direction and about seven metres deep (fig 1), this was found to be the source of an escape of oily water. Tordis lies between the Snorre and Gullfaks fields in the Tampen area (fig 2), and was proven and developed by the former Saga Petroleum company.

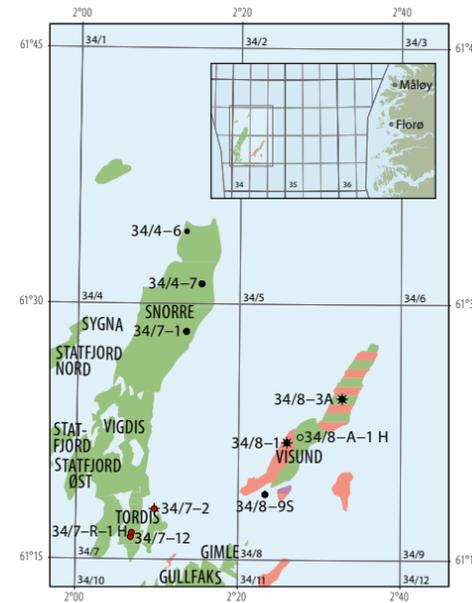
Fig 2: Location of the investigated wells 34/7-2, 34/7-R-1 H and 34/7-12 in the Tordis area (red symbols). The 34/4-6, 34/4-7 and 34/7-1 wells on Snorre and the 34/8-3A, 34/8-1, 34/8-A-1 H and 34/8-9S wells on Visund (black and open symbols) have been checked earlier by the NPD.

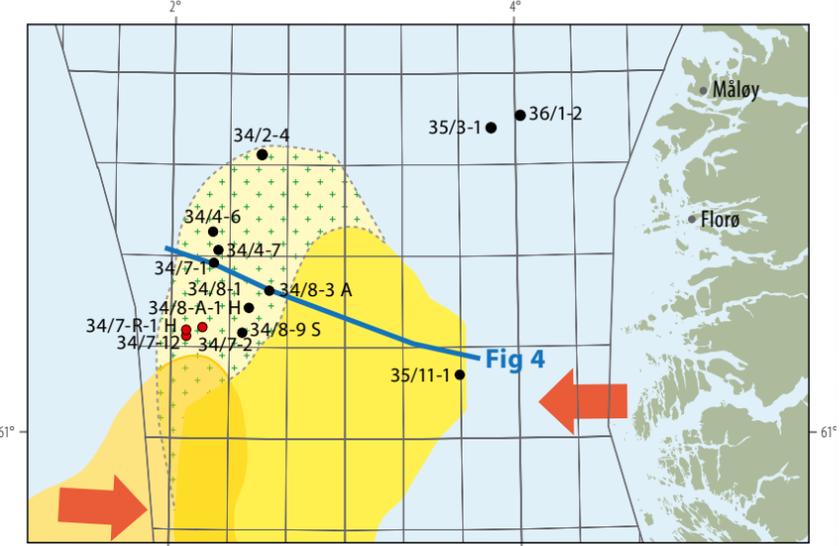
Fig 3: Approximate extent of the Utsira formation on the Snorre, Visund and Tordis fields in the Tampen area of the North Sea. It consists largely of light quartz sand in the areas shown in light and dark yellow, and of dark green glauconitic sand in the area marked in yellow with green stars. Investigated wells are indicated by red symbols in the Tordis area and by black symbols on Snorre and Visund. Red arrows depict the direction in which sediment has been transported. The blue line shows the location of a seismic profile presented in fig 4.

This result is consistent with the conclusions of an earlier study by the directorate 10 years ago on Snorre and Visund, which lie north and north-east of Tordis (fig 3).

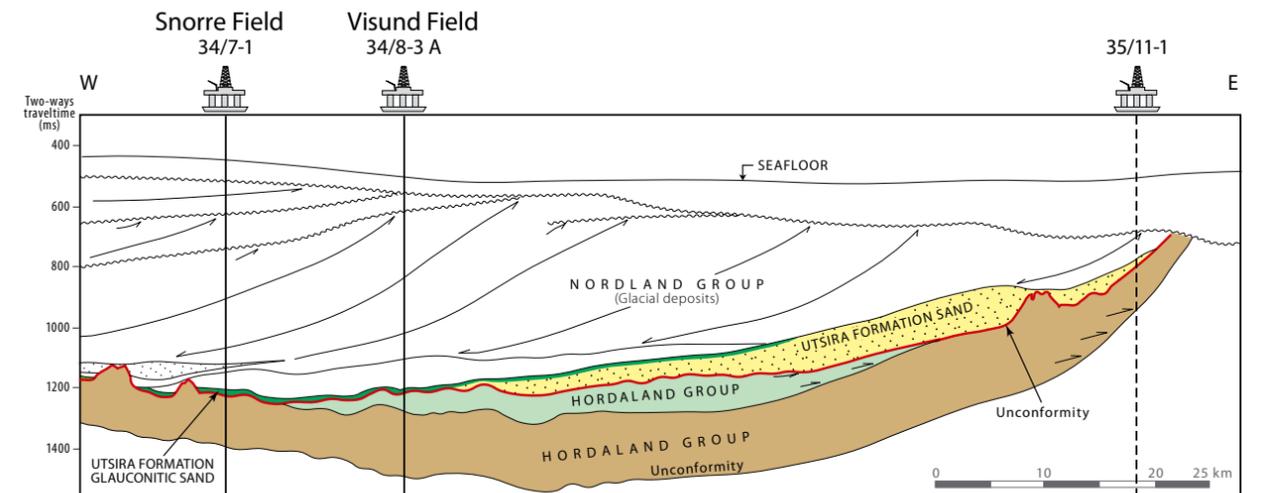
Fig 4: East-west seismic profile through the Tampen area, showing the thickness of the Utsira formation on the Snorre and Visund fields. The location of the profile is shown in fig 3.

poorly developed – in other words, only about 20-60 metres thick – over these areas (fig 4).

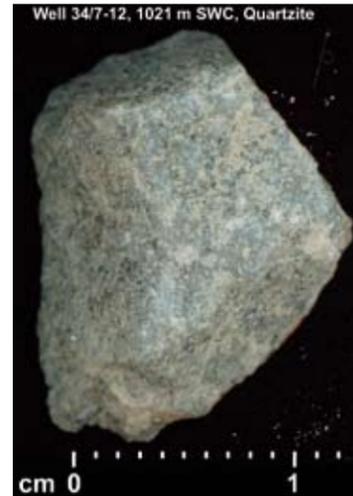
A sidewall core taken close to the bottom of the unit and interpreted by Statoil as the Utsira includes a sharp-edged piece of quartzite measuring 1.8 by one centimetres (fig 5).

This derives from the mainland, and can only have been carried so far out onto the continental shelf by glaciation. But studies of scientific cores from the Norwegian Sea shows that the ice ages only began about 2.75 million years ago in northern Europe.

Fig 5: Sharp-edged quartzite stone found in a sidewall core close to the base of the unit interpreted by Statoil as the Utsira formation. This piece of rock hails from the mainland and must have been carried to the Tordis area during the ice age – long after the Utsira was deposited.

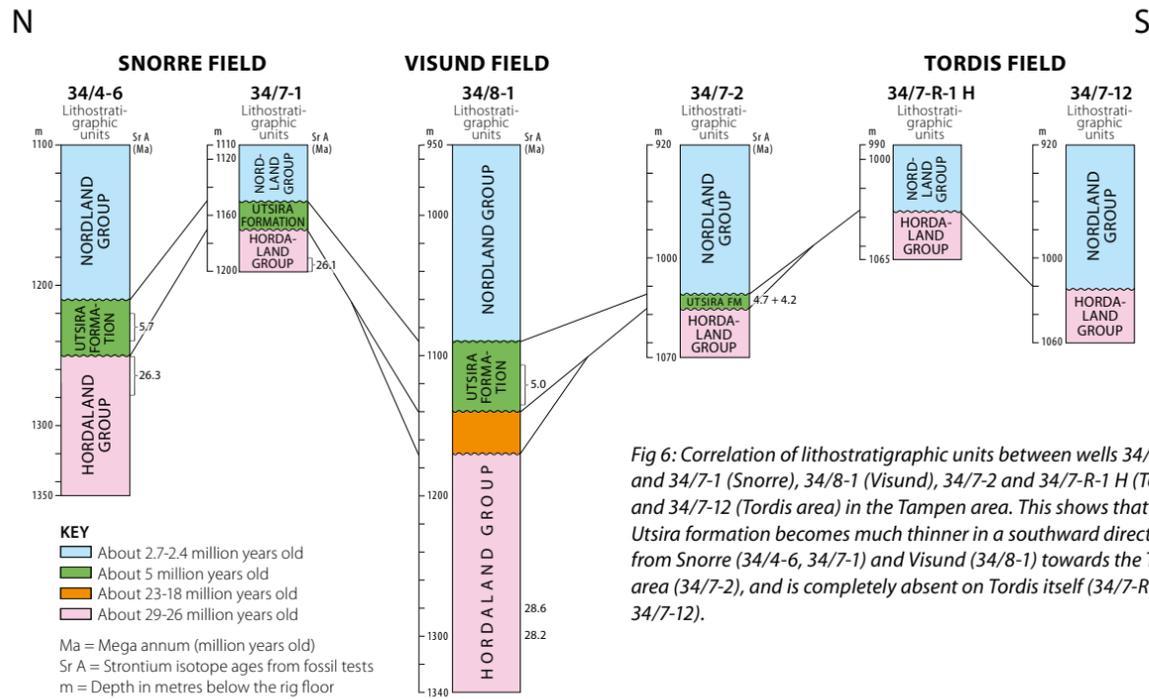
Fig 6: Correlation of lithostratigraphic units between wells 34/4-6 and 34/7-1 (Snorre), 34/8-1 (Visund), 34/7-2 and 34/7-R-1 H (Tordis) and 34/7-12 (Tordis area) in the Tampen area. This shows that the Utsira formation becomes much thinner in a southward direction from Snorre (34/4-6, 34/7-1) and Visund (34/8-1) towards the Tordis area (34/7-2), and is completely absent on Tordis itself (34/7-R-1 H, 34/7-12).
